DUNDEE LAKE DAM

PHASE I INSPECTION REPORT NATIONAL DAM SAFETY PROGRAM

NJ 00243

JUNE 1978

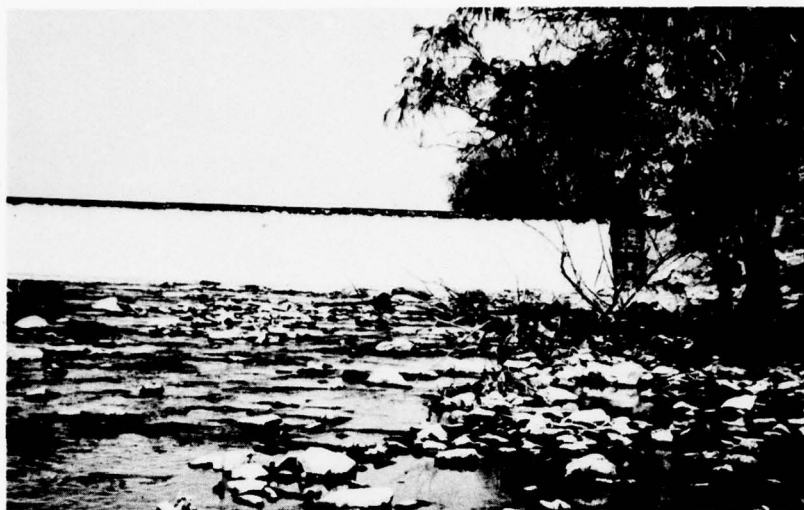
Photo 3 - View from downstream left bank at left abutment

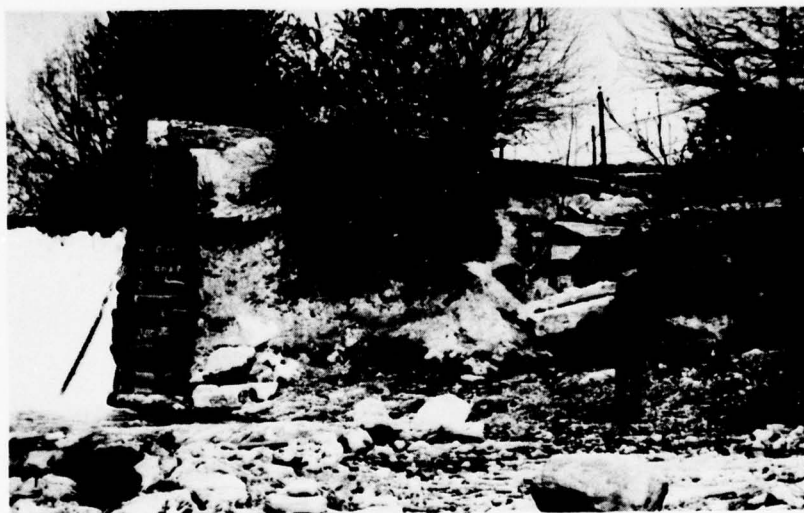
Seepage was observed in two areas, 3 to 5 feet in length, above the toe of the left abutment, approximately 12 to 15 feet from the spillway wingwall. The seepage was estimated to be about 1 gpm at the time of the inspection, and the source is believed to be the reservoir.

Photo 4 - Close-up view of left abutment; seepage is coming out at a point half way between the figure and the spillway training wall

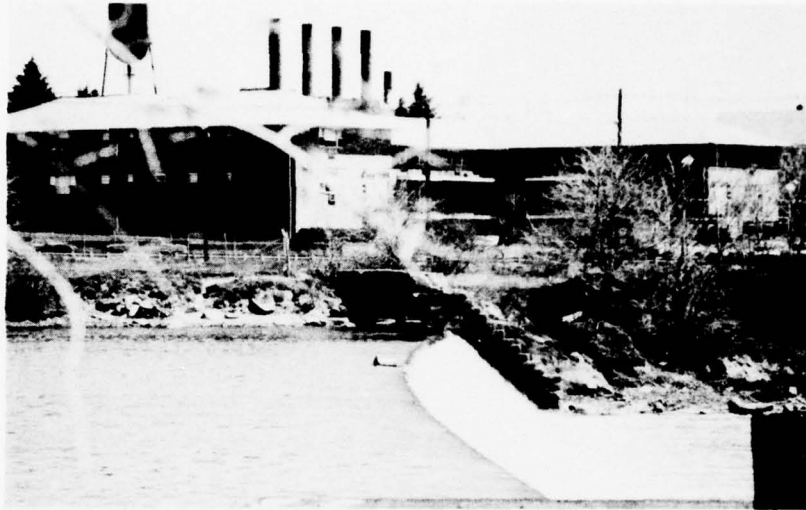
Photo 5 - View of left abutment and left spillway training wall from right abutment

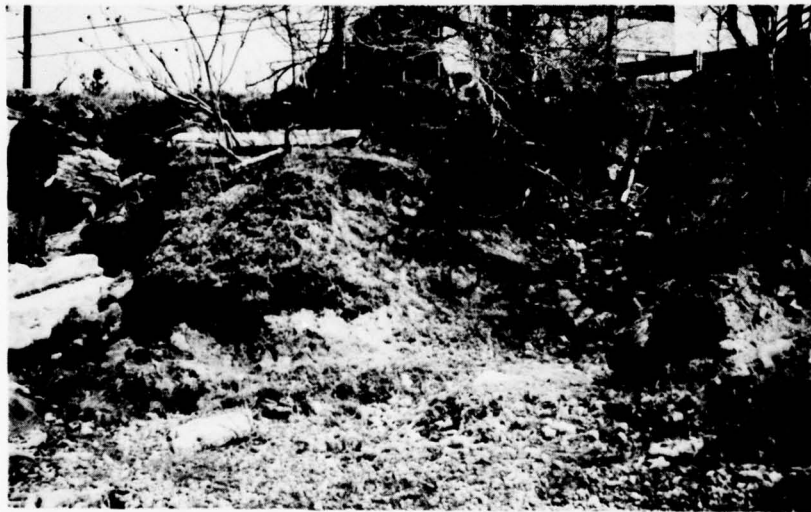
There was no evidence of structural cracking. The left abutment has been partially destroyed or vandalized at the top courses of masonry. The downstream area of the left abutment is severely eroded by drainage

Photo 6 - Close-up view of left abutment area downstream of dam showing stream bank erosion caused by local street drainage overflow

- (1) Regrade the area downstream of the left abutment and protect against erosion and slope instability.
- (2) Make provisions to control surface runoff from River Drive, Garfield.
- (3) Repoint eroded joints in masonry on left and right abutments.
- (4) The riverward canal embankment should be cleared of uncontrolled brush growth and replaced with suitable ground cover.
- (5) Upgrade Operation and Maintenance procedures by issuing an O & M Manual.
- (6) Install head and tailwater gages.

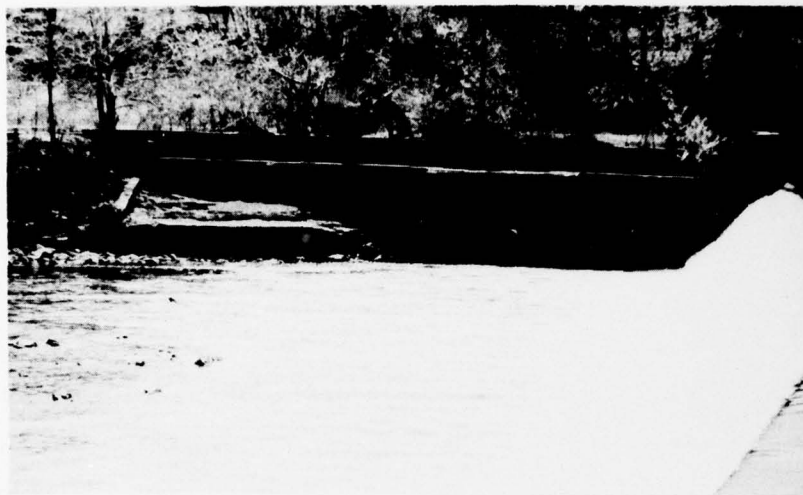
Photo 9 - River wall of Dundee Canal intake; the wall has been lowered to act as a water level control weir for the Dundee canal at high flow rates of the Passaic River; wall is leaking at places through masonry joints
